FATIGUE DAMAGE AND REPAIR OF AN ORTHOTROPIC PLATED BRIDGE DECK AFTER 23 YEARS OF SERVICE

Philippe Van Bogaert¹

Civil Engineering Department, Ghent University (Belgium)

Key words: *Fatigue damage, orthotropic plated deck, crack repair, movable bridge, replacement bridge deck*

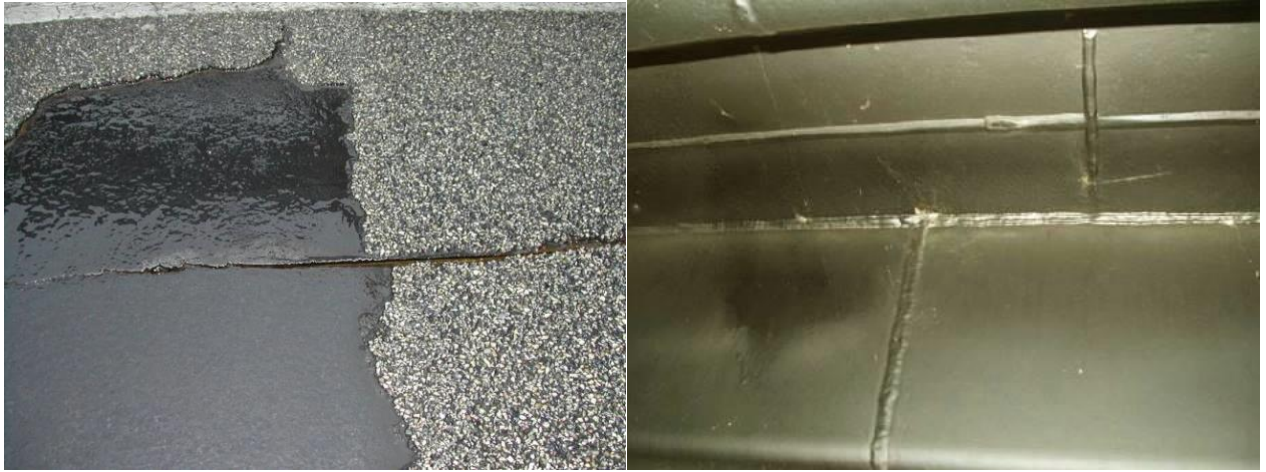
Already in 2004, after 10 years of service, the OSD showed rapidly increasing cracks [3] at the connection of closed-section stiffeners and the deck plate. A rapid repair method was implemented. Fig. 3 shows the crack through the surfacing. Obviously the crack grew from the right side of the picture to the left. At the time, the writer was contacted, the crack through the 12 mm thick steel deck plate had grown already to a length of 600 mm. Inspection of the crack surface was impossible, although one could suspect that fatigue was the cause of such a rapidly growing crack.

As the lower side of the bridge deck was inspected, the initiation of the cracks appeared to correspond to the location of the connection of the closed stiffener to the deck plate, more precisely to the intersection of this weld with the butt weld in the stiffener as shown in Fig. 3. The stiffener to deck plate connection is known to be a detail, particularly prone to fatigue. If this fatigue detail is combined with the transverse butt weld a particularly heavy stress concentration is introduced. As can be noticed from Fig. 3 none of the butt welds received post-treatment such as grinding, as should certainly be applied in

orthotropic plated bridge decks. It was immediately suspected that this particular situation was the cause of the rapidly growing crack.

Fig. 3. Crack in deck plate (left) interference with stiffener butt weld (right)

Simultaneously, numerical simulations proved that cracking was due to fatigue of the stiffener to deck plate welding and that the 10 year life time could easily be explained. Due to the intersection of welds, the stress at the connection itself is increased by the butt weld by a concentration factor of 1.19. Hence, the problem was local only and further general cracking was not expected immediately. However, the general condition of the OSD appeared rather poor and the prediction was that fatigue cracks of the type of Fig. 3 would become general within 6 to 10 years. The present paper reports on the fatigue damage that occurred, 14 years later and recent measures that were taken.

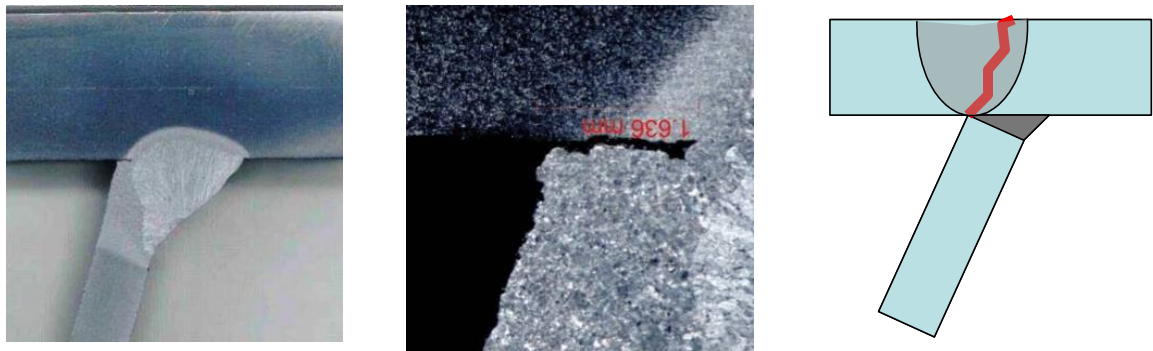
As the most critical section of the stiffener to deck plate connection is located at the root of the welding, shown in Fig. 4. This is why there is no direct evidence that the extrapolation method for hot spot stress may be copied for this particular welding detail. However, the latter is frequently assumed, also in the former paper on fatigue damage of the River Scheldt bridge [3]. Fig. 4 left shows a macrographic photo of the typical one-sided welding connection of the stiffener to the deck plate, whereas the right hand side displays the orientation of the fatigue crack, originated at the weld root and progressing to the top of the deck plate. The shaded area in the figure corresponds to the heat affected zone.

Fig. 4. (left) single side welding (centre) detail of stiffener (right) fatigue crack path

Obviously, the numerical modelling of this connection must include the small gap or lack of welding penetration. Most simulations introduce such a gap, including a round tip at the end. Microscopic research has proven that such a fillet rounding is close to reality. However, there is little difference in fatigue strength between a connection of 20% lack of penetration and a full penetration welding. This is due to the high influence of residual stress at this location. The crack path of Fig. 4 right can only be found numerically if the effect of residual stress is included.

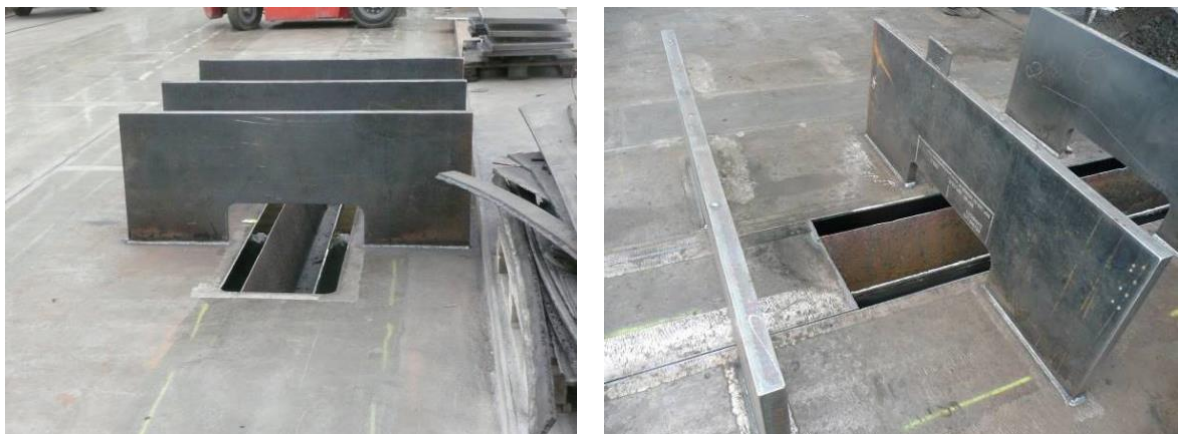
In 2017 TOFD non-destructive testing was carried out on the deck plate of the movable part of the River Scheldt bridge. It demonstrated that the plate was cracking rapidly, since 14 m length was seriously affected. Some cracks already were visible through the 7 mm pavement of the bridge deck, and there was a high probability that more in depth cracking was initiated or already. As these cracks are invisible, extensive testing became necessary. The owner decided to have these parts of the deck plate repaired, according to a procedure involving the replacement of the plate from above and rewelding of the connection of Fig. 4 [8] from below the bridge.

Fig. 6. Removal of cracked parts of deck plate

The repair method may best be illustrated through the pictures of Fig. 6. Vertical plates, are bridging the cracked part of the deck plate. This allows to burn the circumference of the plate area and to cut the welds of the connection of Fig. 6. This condition is shown in Fig. 6 left. Fig. 6 right shows the precise cut in the deck plate.

Subsequently, a new part of deck plate is being placed and welded to the free edges. As for the connection to the closed stiffeners, this is welded from below, using a suspended rack. The replacing deck plate is increased from 12 to 16 mm. Hence, a higher resistance for bending is obtained and cracking will become less critical.

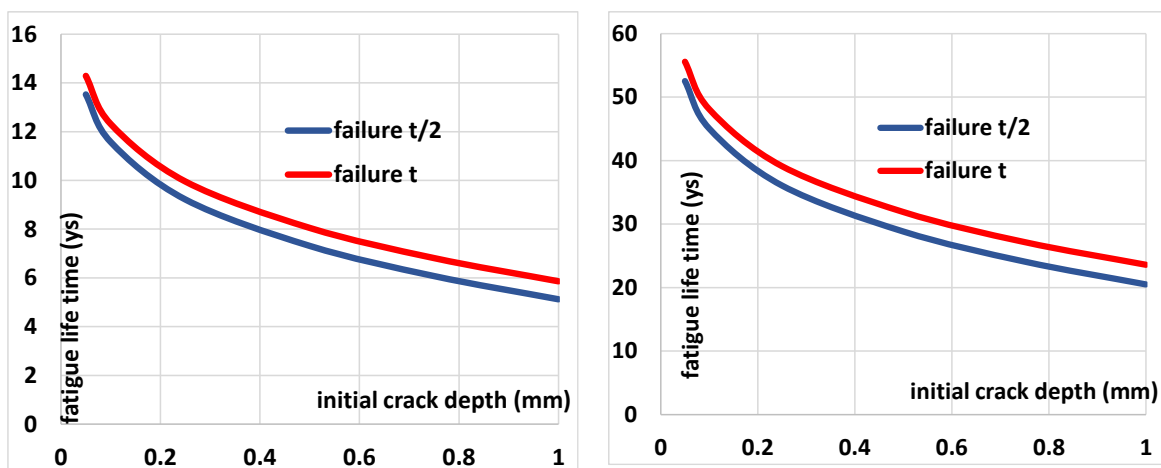
Using the value of $f(a)$ derived in [8], which include the effect of residual stress, the crack depth can be calculated. Obviously, the value of the initial crack depth is a dominant factor. The graphs of Fig. 8 show the result, to the left for a 12 mm thick deck plate and to the right this plate is increased to 15 mm.

Fig. 8. Fatigue life prediction by LEFM

The graphs of Fig. 8 each show 2 curves, the failure point being an uncertain condition. Generally, failure is considered to occur when the crack depth reaches half the plate thickness and the curve $t/2$ is relevant. From the tests reported in [8] the initial crack depth is close to 0.1 mm. In that case, the result of LEFM is that for the initial structure fatigue life would have been 13.53 years, whereas if the deck plate thickness is increased to 15 mm it would become 52.53 years. The latter does not comply to the requirement of

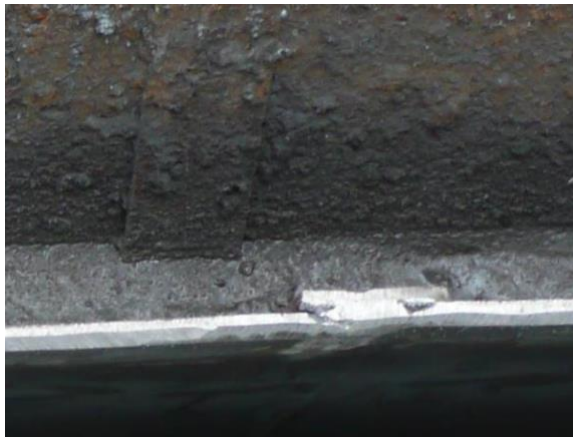
During the aforementioned repair works, welders found that the actual joint of the stiffener to the deck plate showed less penetration than Fig. 4 left. This is based on testimony from persons and could not be confirmed directly by material evidence. However, the cut edge of the stiffener could be examined closely and the flat part of the web plate top has been measured. Details of this are shown in Fig. 9.

Fig. 9. Closer image of stiffener upper edge

The value of the horizontal flat part of the web edge varies from 4.7 to 6.3 mm, the web thickness being 8 mm. This may confirm the claim of the welders. Obviously, the flat part of the web thickness is irregular and may be influenced by the cutting itself. Nevertheless, a rather evenly distributed area was found as the pictures of Fig. 9 may display.

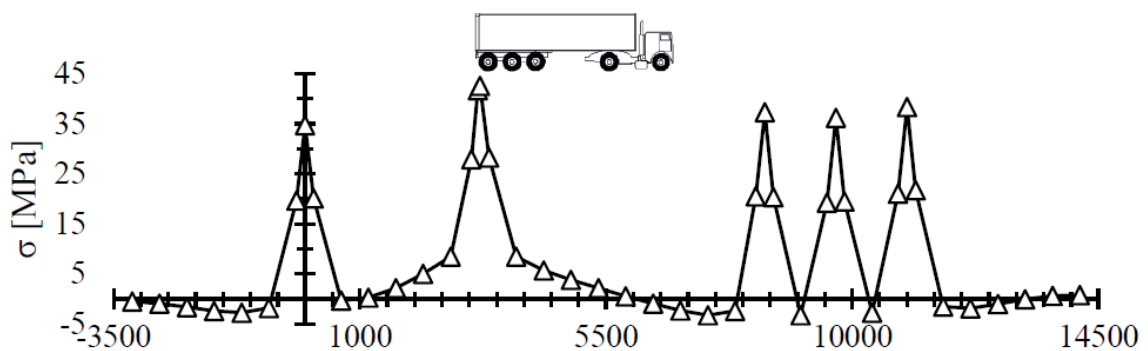
Fatigue rainflow count, according to EN 1991-2 [9] may further be useful in trying to evaluate the failure condition as well as the future replacement alternatives. Using FLM 4, consisting of 5 lorries and adopting the case of long distance traffic, the failure condition at 22 years corresponds to a failure value of 91.6 MPa. In this it was assumed that traffic intensity equals $1.4 \cdot 10^6$ per year, corresponding to 2800 vehicles per day. Fig. 10 shows the nominal stress variations due to lorry 3 of FLM 4.

The failure value of 91.6 MPa does not correspond to a fatigue class as in the code, since it does not include any statistical parameter. In addition, no factor γ_{MF} is included. Thus it cannot be used as a design parameter. It does however correspond closely to the value 87 MPa as mentioned in [10]. According to this reference, the design stress range would be 70 MPa, whereas the code classifies this as 50 MPa. Clearly, this welding quality is not suited for a bridge deck with heavy road traffic. A similar rainflow fatigue count shows that the design stress range should equal 111.3 MPa, in order to obtain a fatigue life of 100 years.

Fig. 10. Stress variation caused by lorry from EN 1991-2

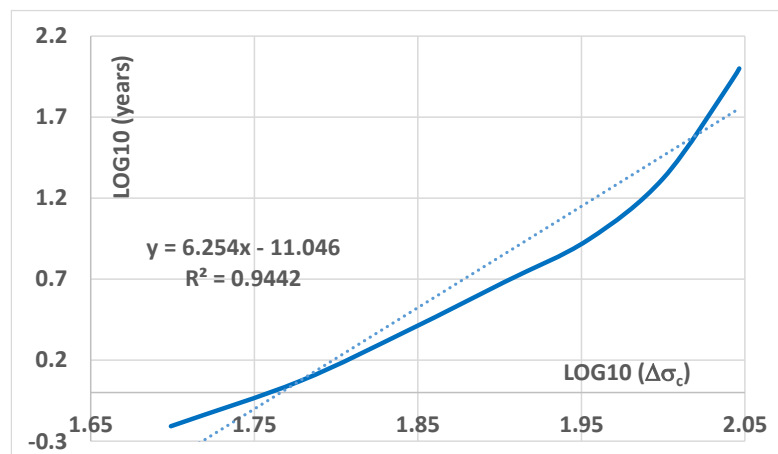
Fig. 11. Relation of design fatigue category and fatigue life

The process has been repeated for various values of the design stress variation, resulting in the bi-logarithmic graph of Fig. 11. A linear relation may be expected, although the ascending curve may be explained by the exceeding of the cut-off limit. Since the required design category needed to obtain 100 year fatigue life equals 111.3, no practical solution exists to replace the movable part of the bridge. Should the deck plate thickness be increased to 15 mm, the design stress category should equal to 71.3 MPa, which is consistent with the code.

Hence, the fatigue damage and subsequent general failure of the River Scheldt bridge may well be due to insufficient welding quality and the movable part may be substituted by an identical structure, provided the deck plate thickness is increased to 15 mm and partial penetration welding is used. In this manner, this historic structure, inspired by its predecessor from Eiffel's time, may be preserved for the future and standing as a landmark.
